**INTERSTATE 29 NORTHBOUND  
BRIDGE over the  
PERRY CREEK CONDUIT**

**SIOUX CITY, IOWA**

**FIRE DAMAGE INSPECTION  
REPORT**

**NOVEMBER 2, 2019**

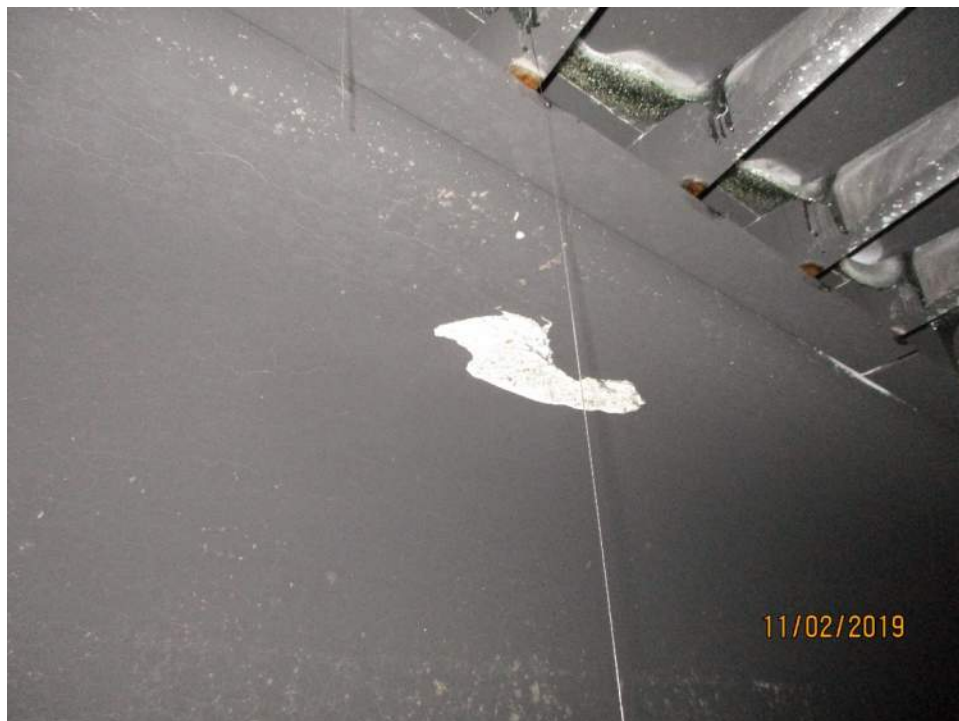
- Web spalling was observed on the north face of Beam "D" and the south face of Beam "E".
  - Sounding indicated delaminated concrete on the top flange of the north face of Beam "D" as well as the top flange on both faces of Beam "E".

*Photo 040: Beam “E” – Top Flange Spalling, North Face*

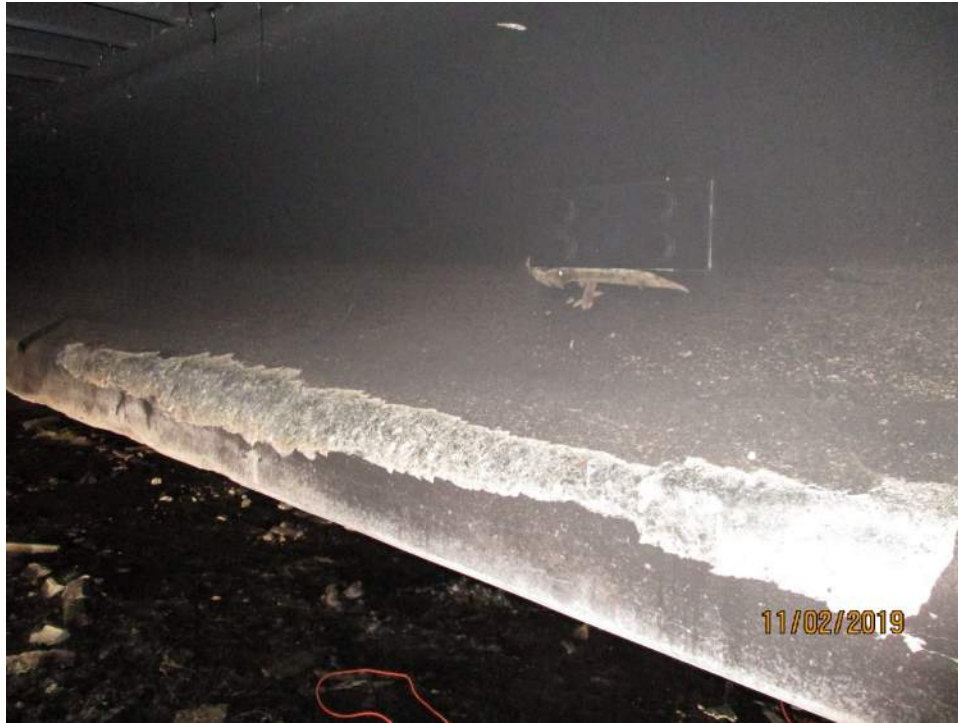
*Photo 041: Beam “E” – Bottom Flange Spalling, North Side*

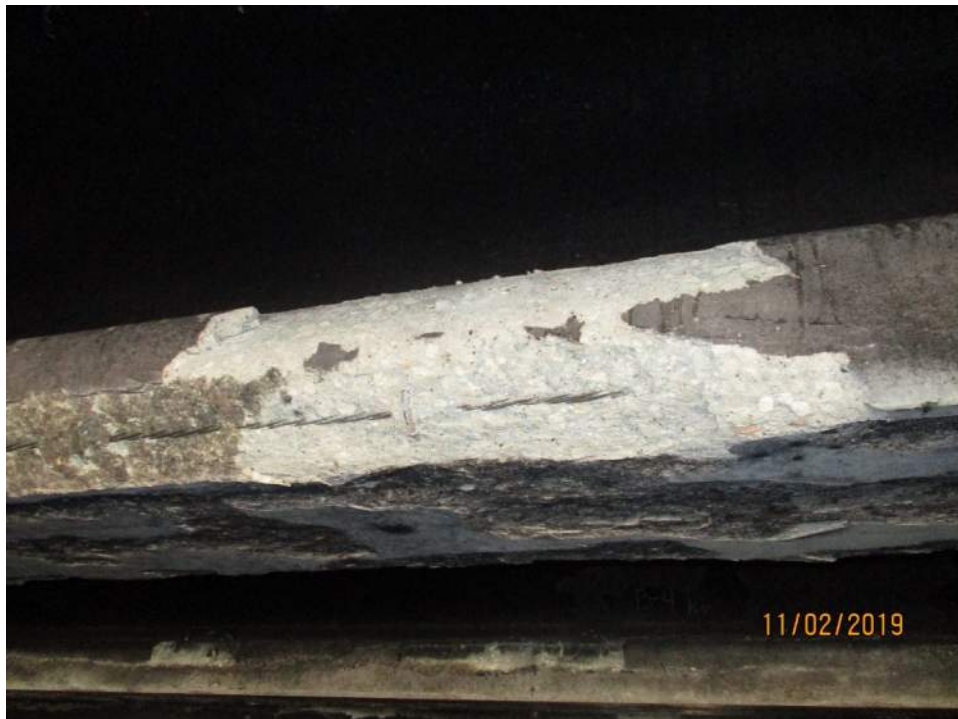
*Photo 042: Beam “E” – Exposed Strand and Stirrup, North Face*

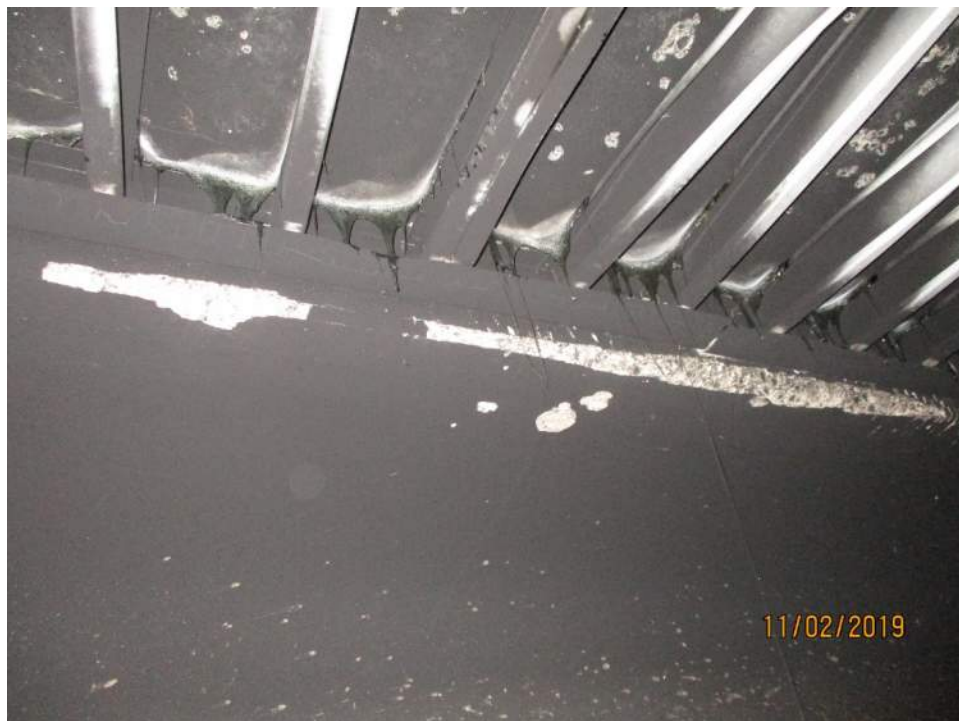
*Photo 046: Beam "E" – Top Flange Spalling, North Face*

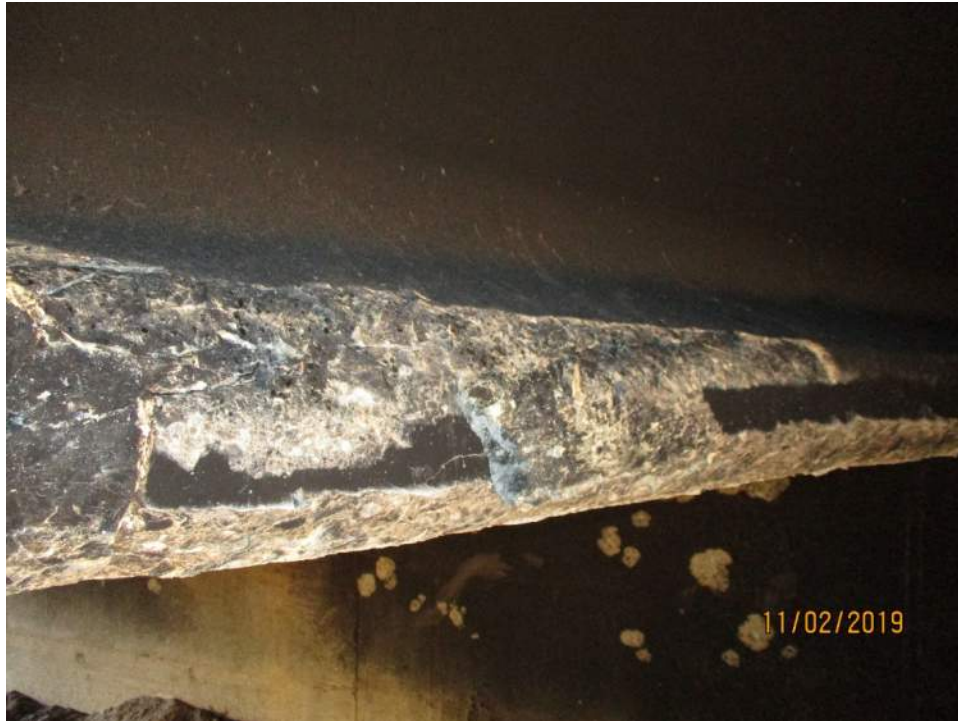
*Photo 047: Beam "E" – Bottom Flange Spalling, South Face*

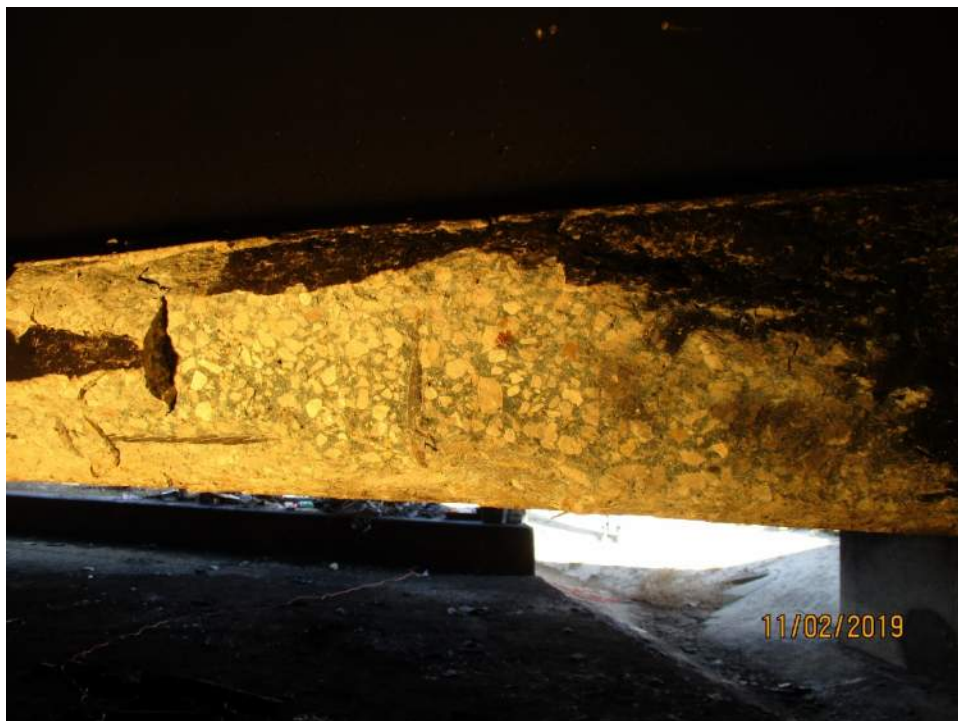
*Photo 048: Beam "E" – Exposed Strand and Stirrup, South Face*

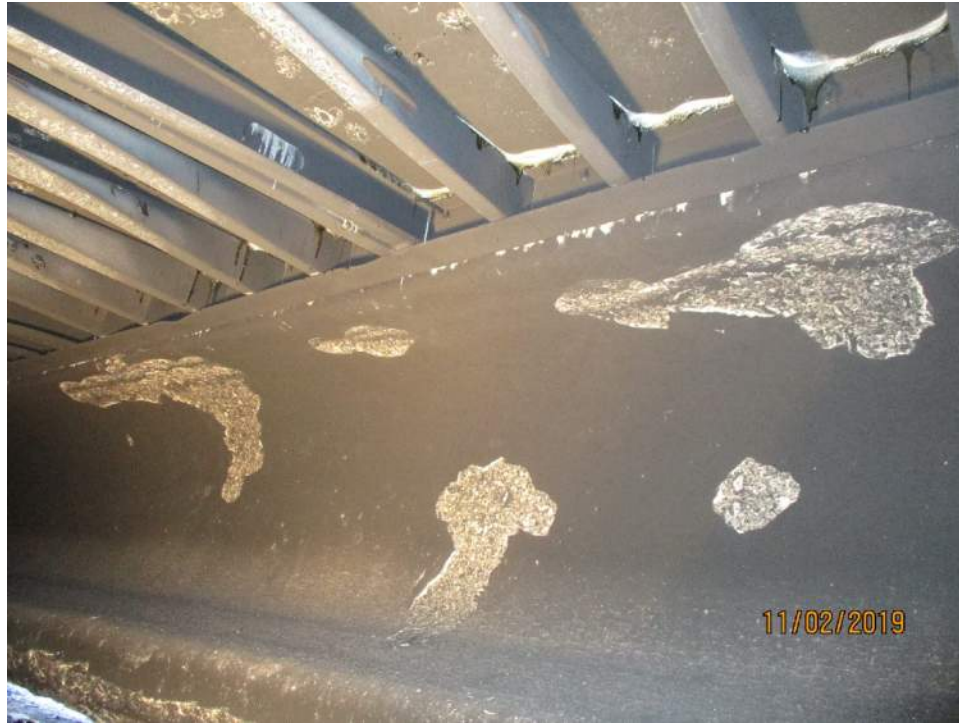
*Photo 049: Beam “E” – Web Spalling, South Face*

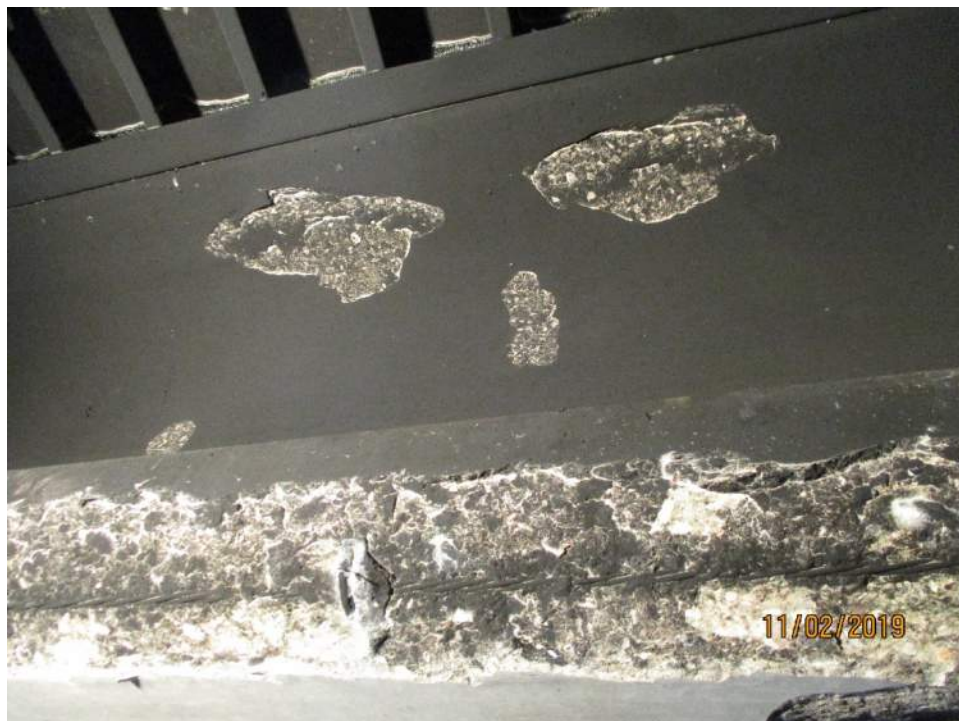
*Photo 050: Beam “E” – Exposed Strands and Web Spalling, South Face*

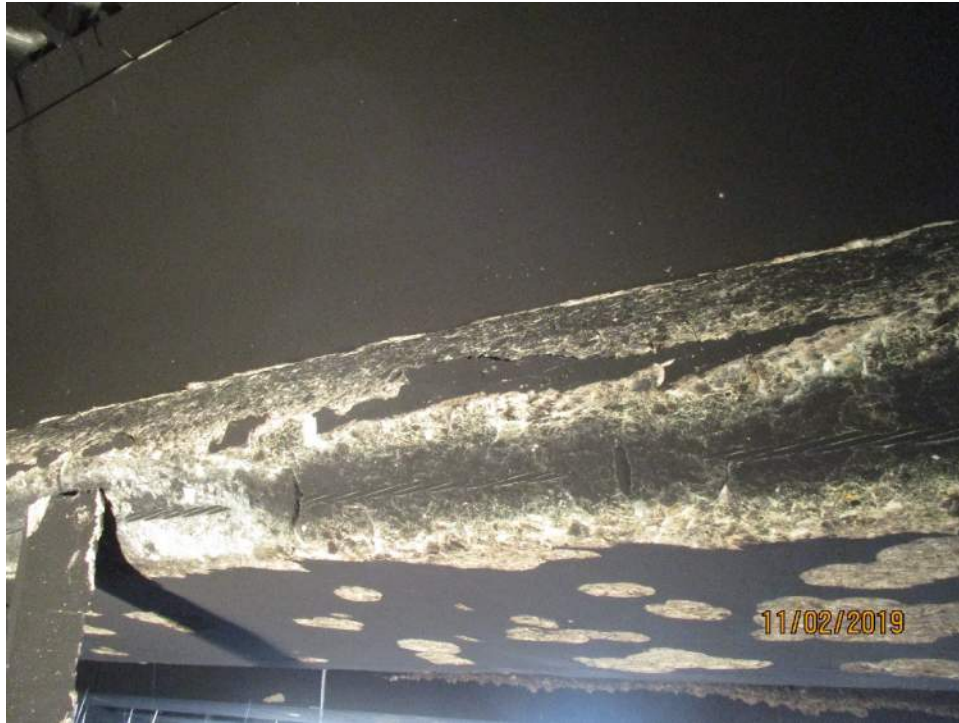
*Photo 051: Beam "E" – Exposed Strand and Stirrup, South Face*

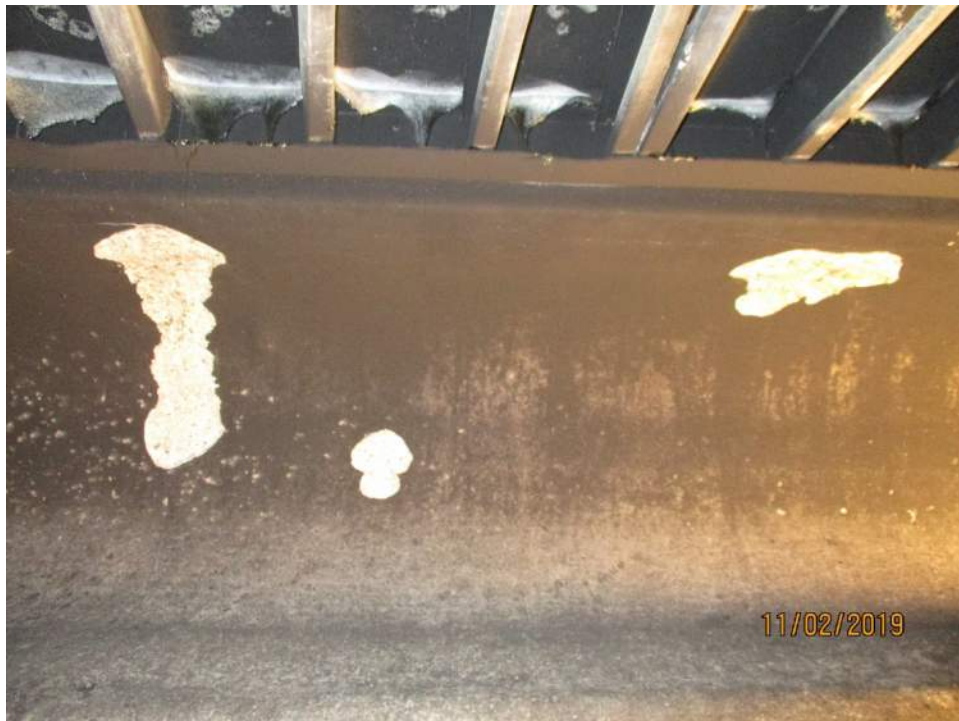
*Photo 052: Beam "D" – Web Spalling, North Face*

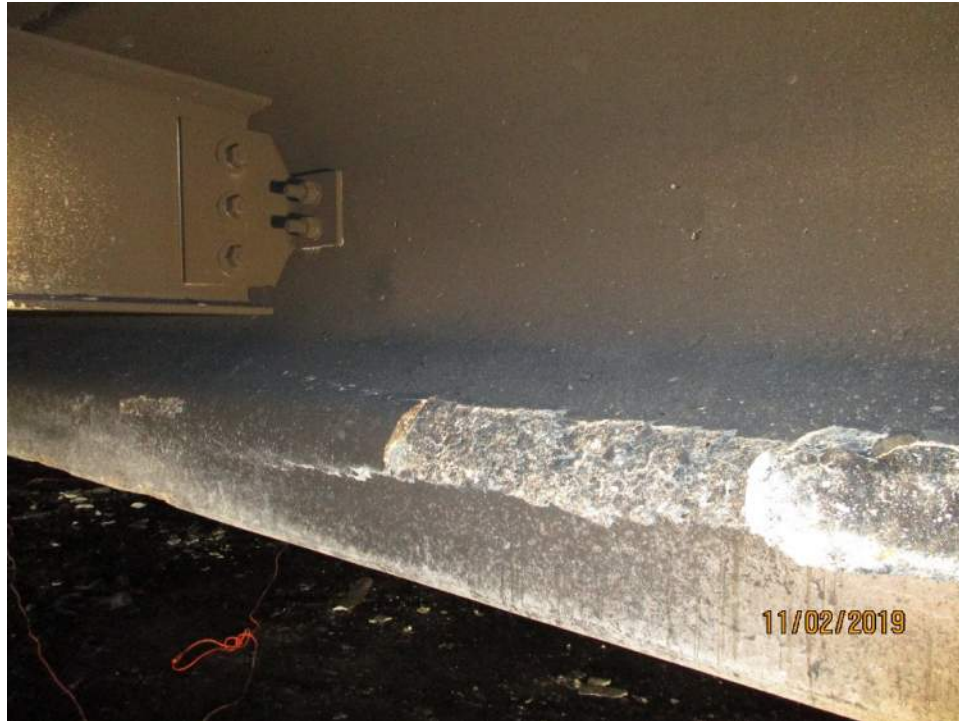
*Photo 053: Beam "D" – Bot. Flange Spalling, North Face*

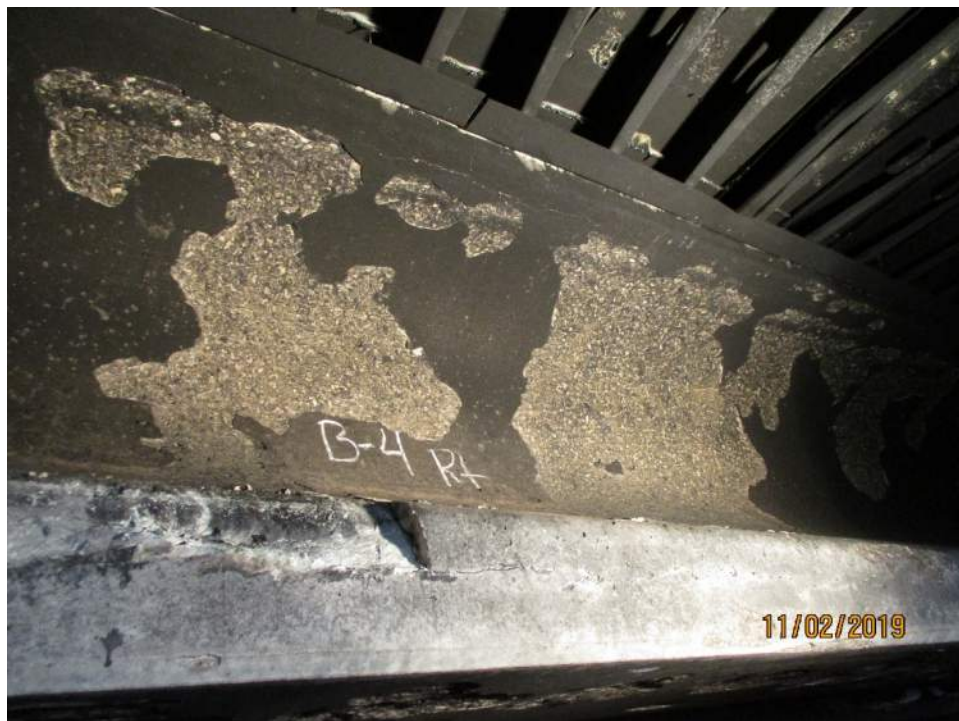
*Photo 054: Beam "D" – Web and Top Flange Spalling, North Face*

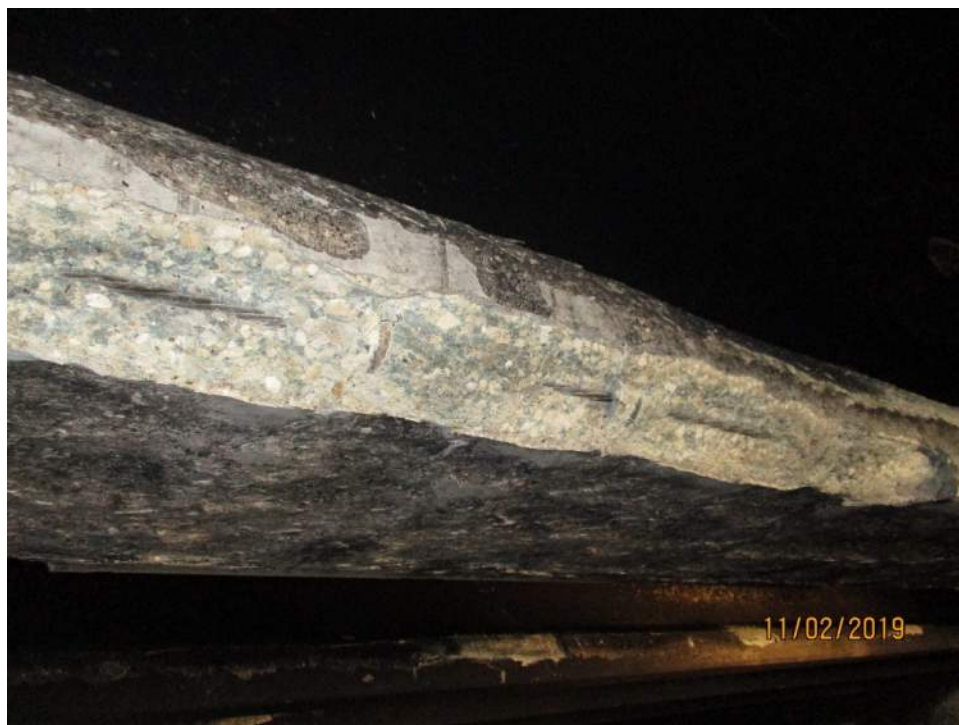
*Photo 055: Beam “D” – Exposed Strand and Stirrups, North Face*

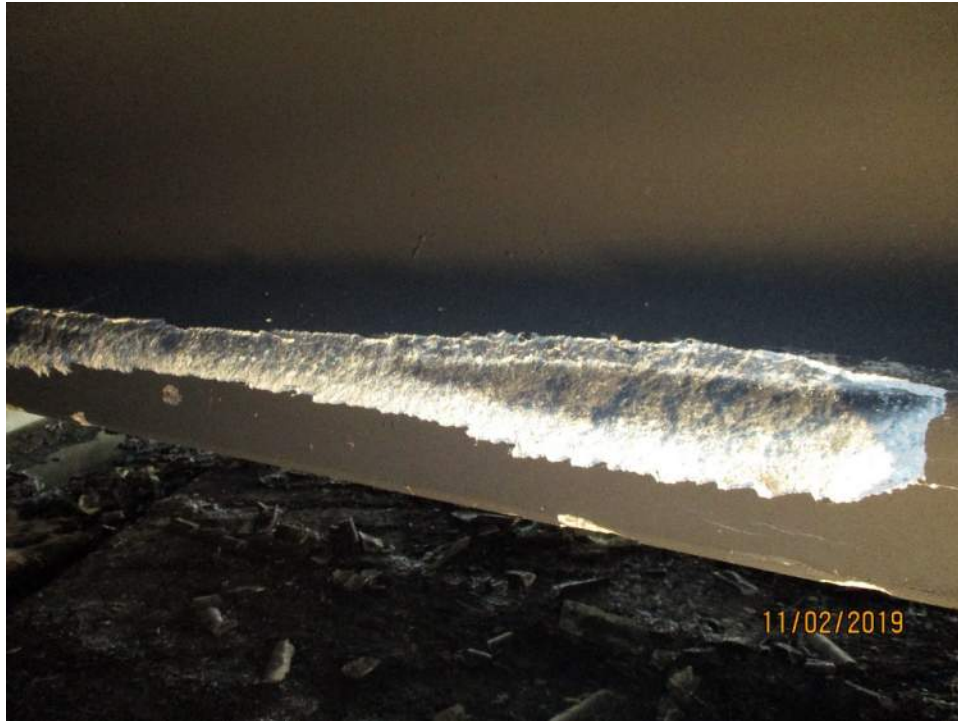
*Photo 059: Beam "D" – Bottom Flange Spalling, South Face*

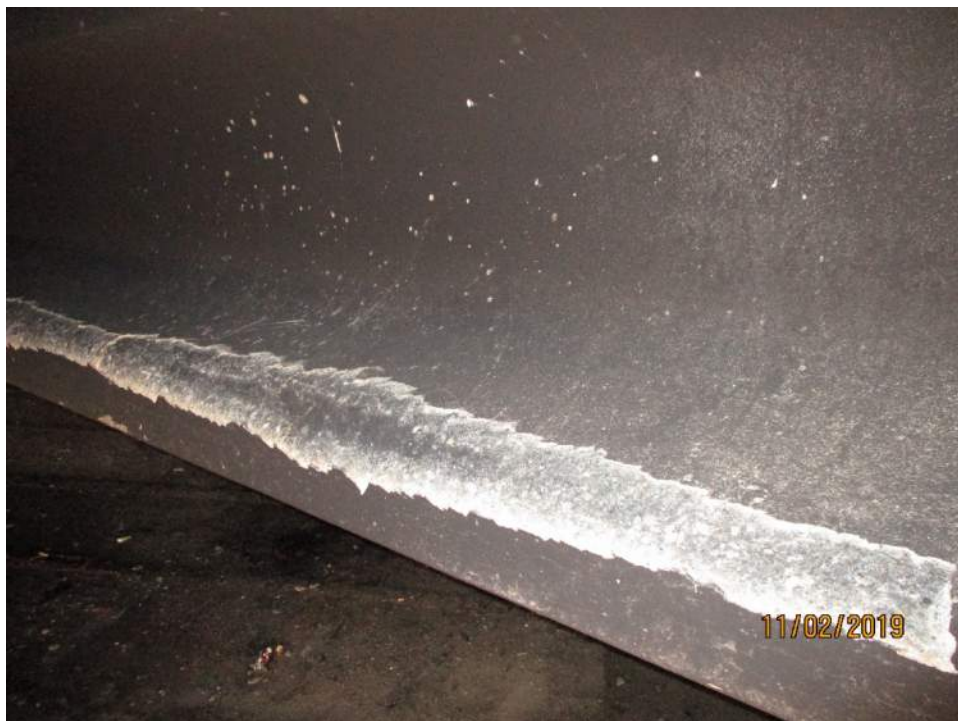
- Beam "C" was observed to be soot covered with surface spalling along the top edge of the bottom flange on the north face.
  - A single isolated spall to the depth of the prestressing strand was observed approximately  $\frac{1}{4}$  of the span length from the east abutment.

*Photo 060: Beam "C" – Bottom Flange Spalling, North Face*

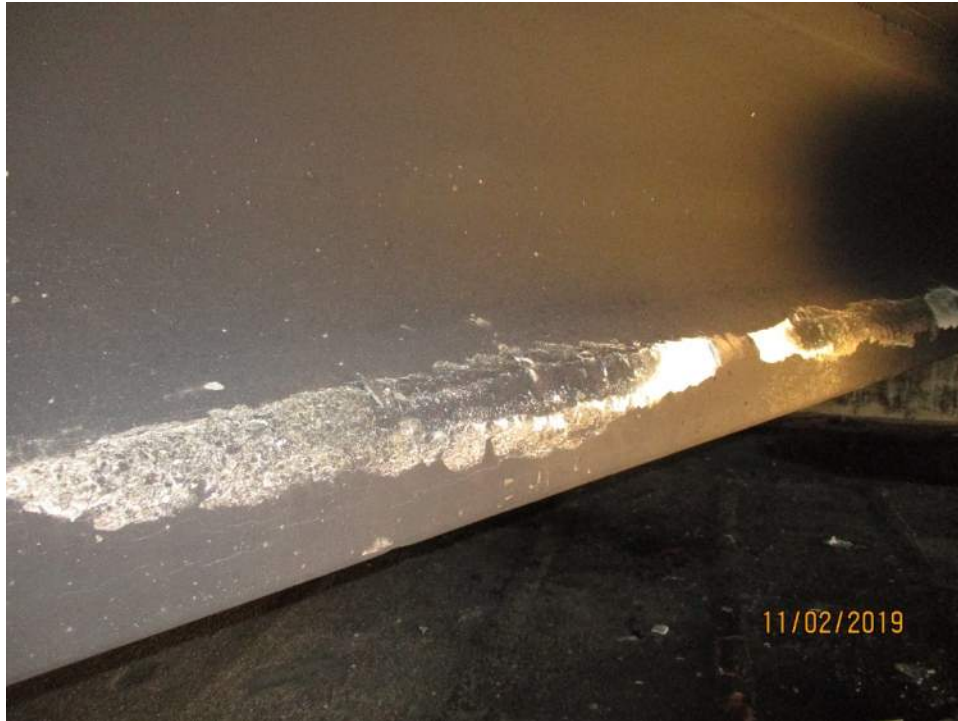
*Photo 061: Beam "C" – Bottom Flange Spalling, North Face*

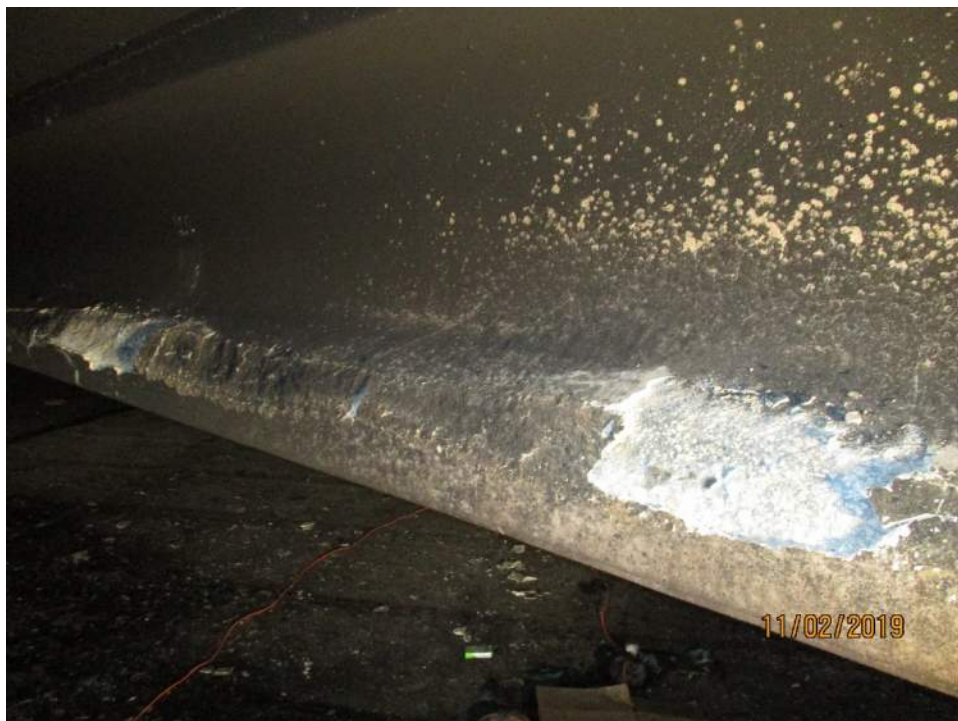
*Photo 062: Beam "C" – Bottom Flange Spalling, North Face*

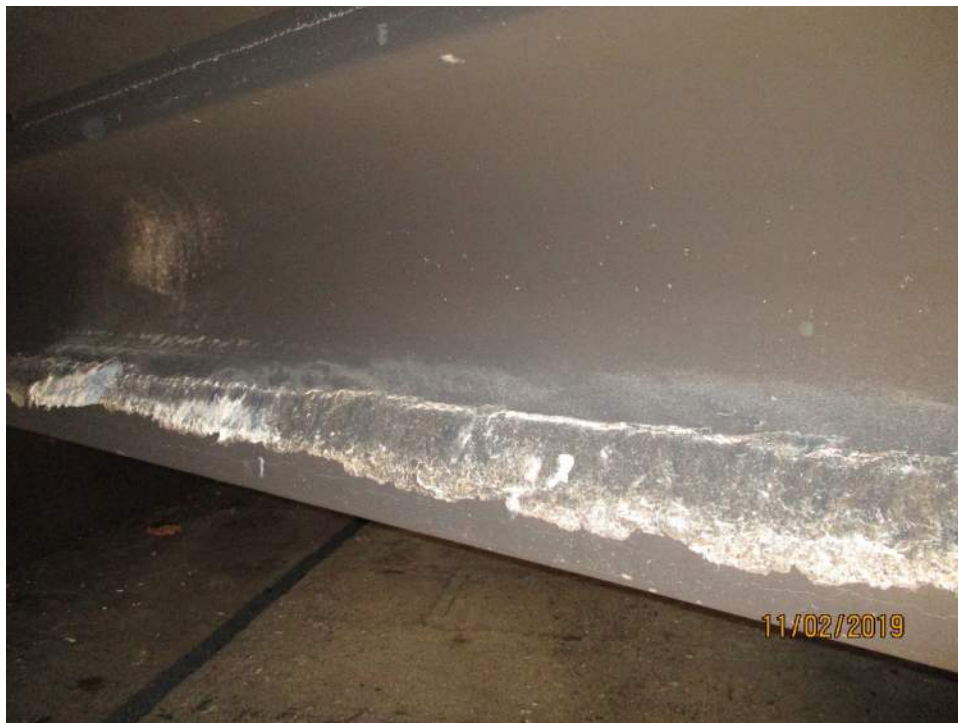
*Photo 063: Beam “C” – Bottom Flange Spalling, North Face*

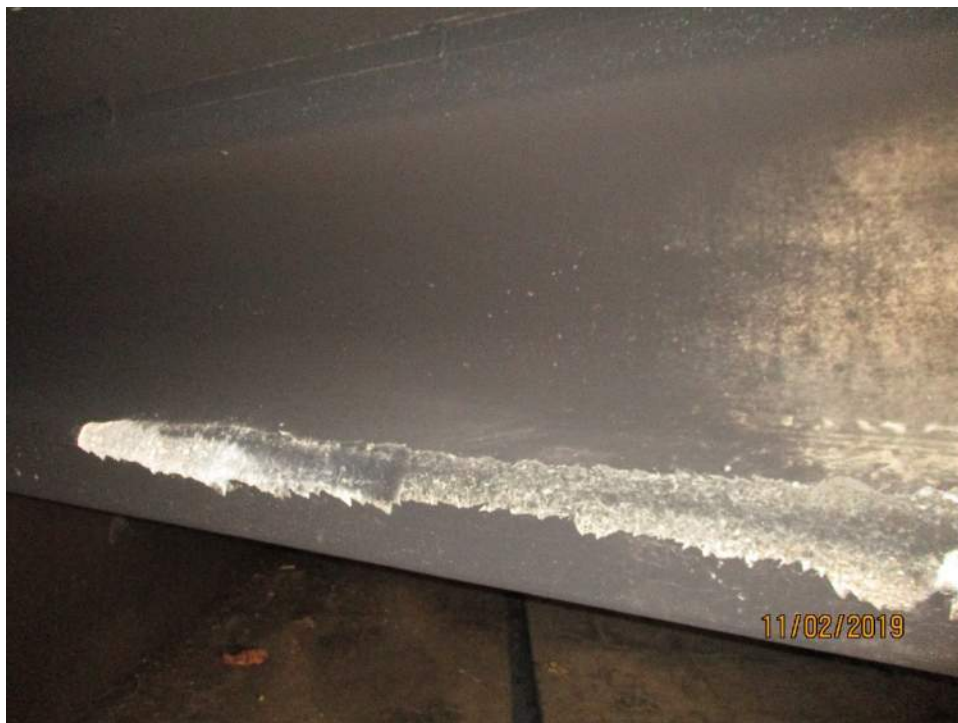
*Photo 064: Beam “C” – Bottom Flange Spalling, North Face*

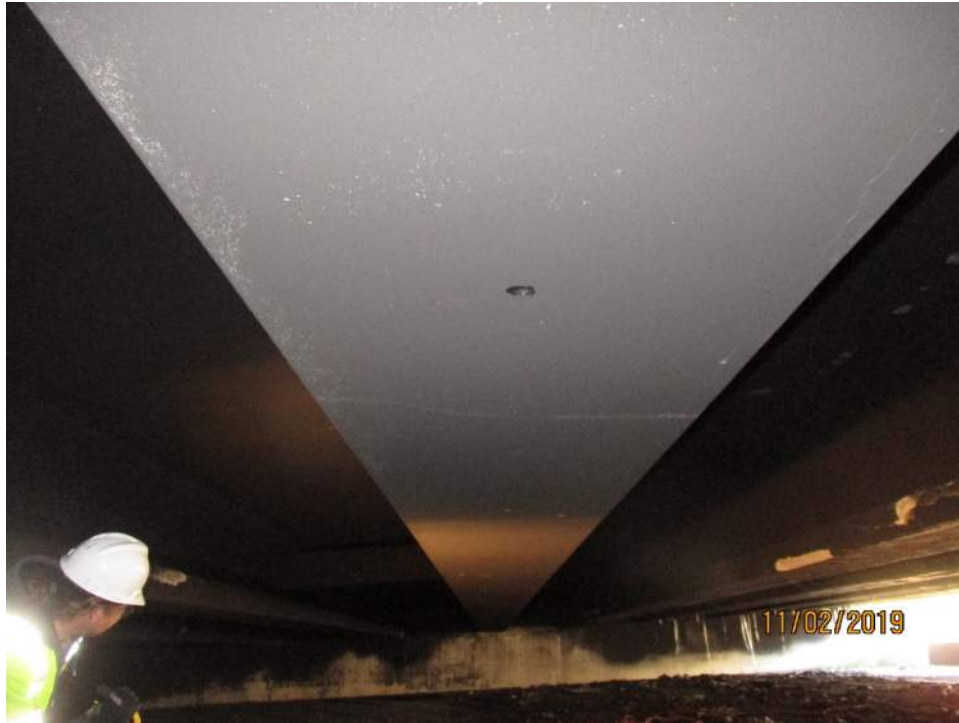
*Photo 065: Beam "C" – Bottom Flange*

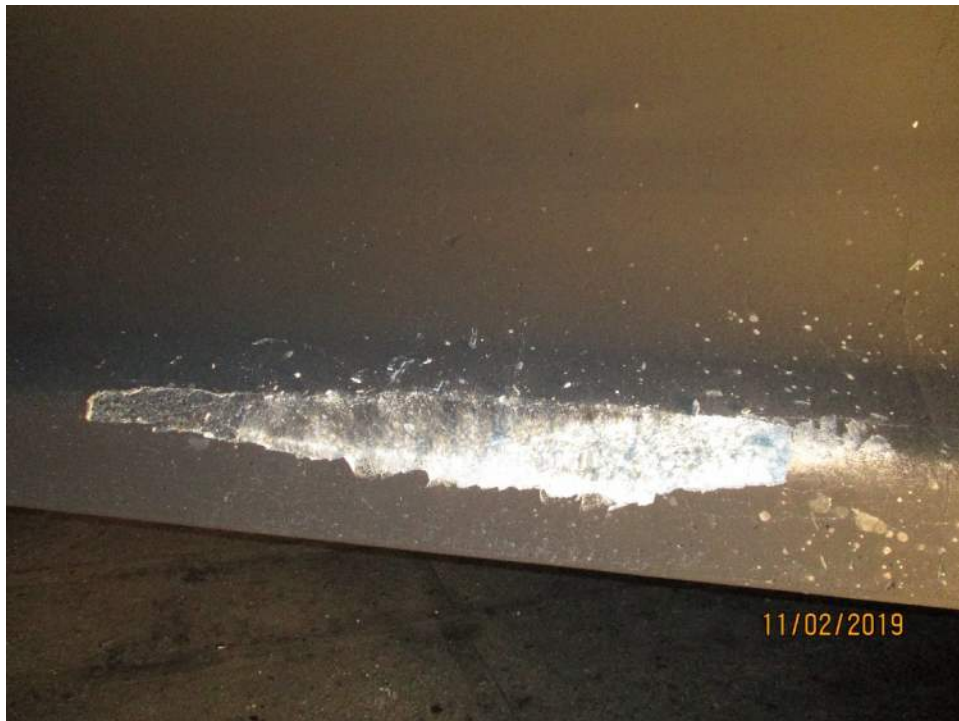
- **Beams "A" and "B"**
  - Beams "A" and "B" were observed to be covered with a thick layer of soot with little visible damage.
  - A single isolated spall was observed on the top edge of the bottom flange of the north face of Beam "B", approximately  $\frac{1}{4}$  of the span length from the east abutment.

*Photo 066: Beam "B" – Isolated Spall, North Face*

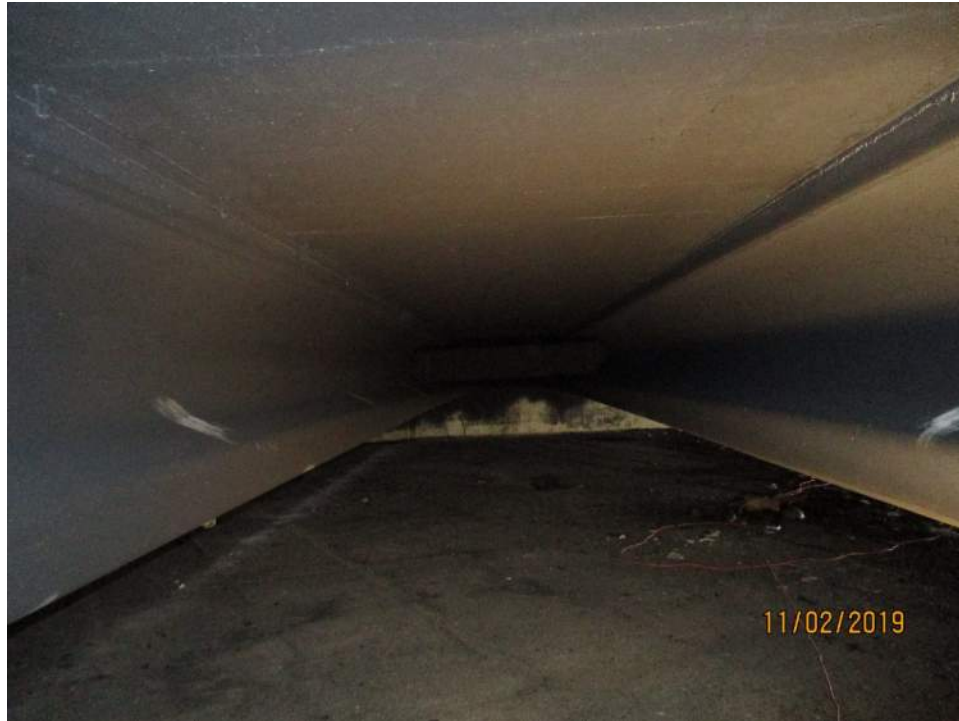
*Photo 067: Bay Between Beam "B" and Beam "A", Facing West*

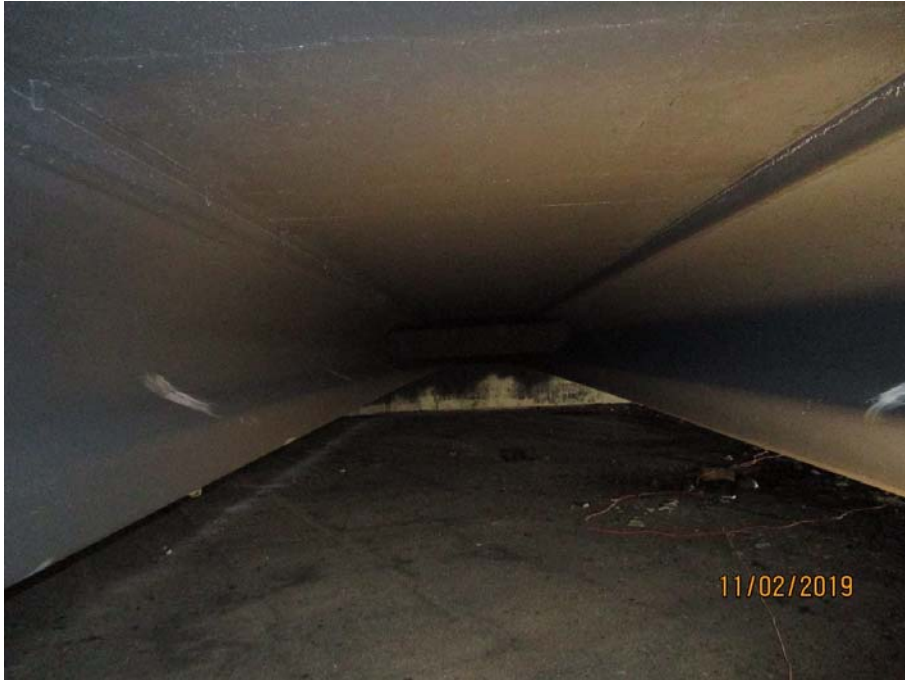
GIRDER "A"/"B" & "B"/"C" - TYPICAL  
CONDITION

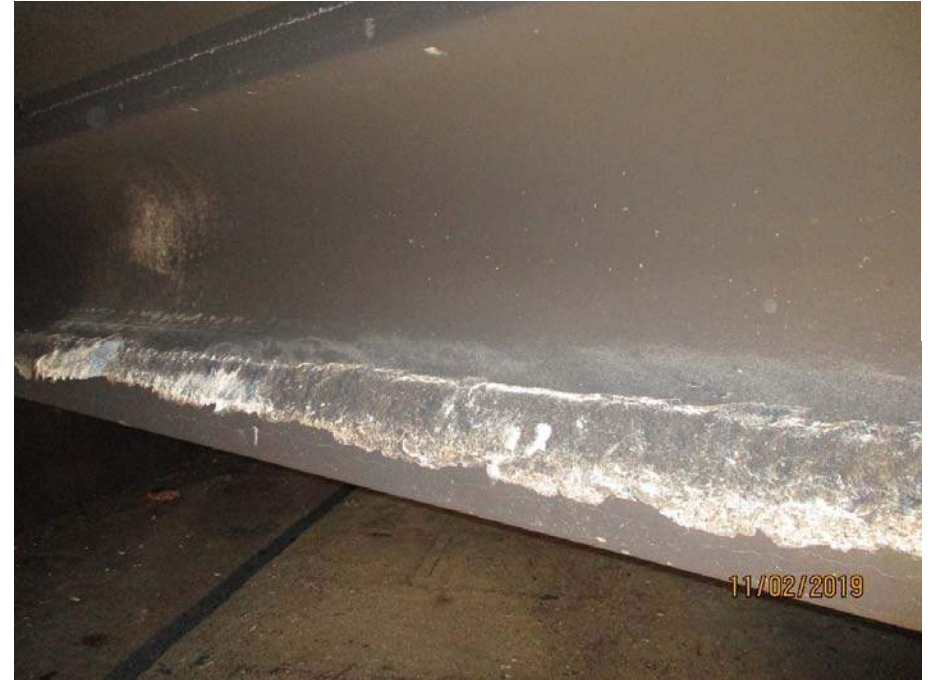
GIRDER "C" – MINOR BOTTOM FLANGE  
SPALL, NORTH FACE

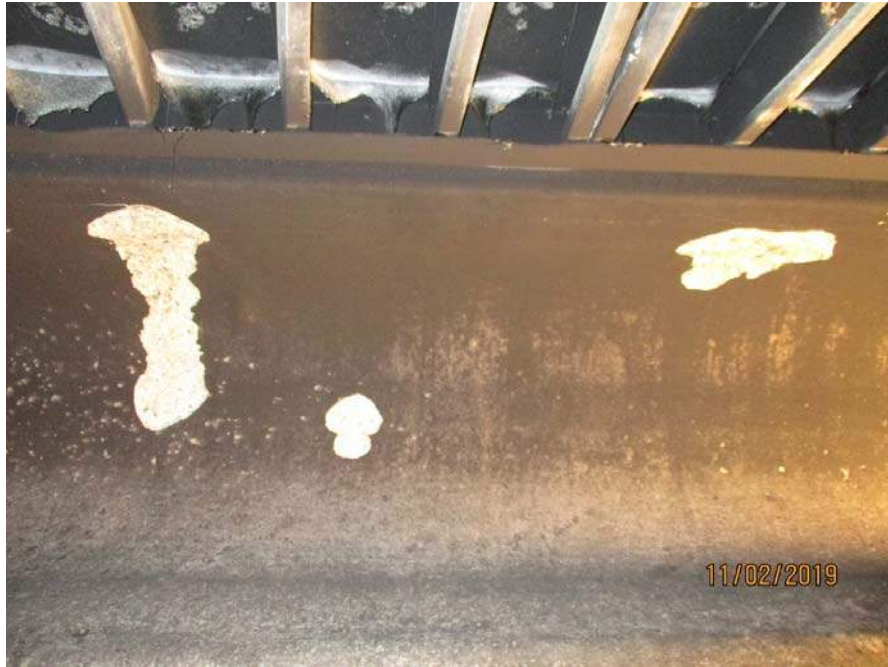
GIRDER "D" – WEB SPALLS, NORTH  
FACE

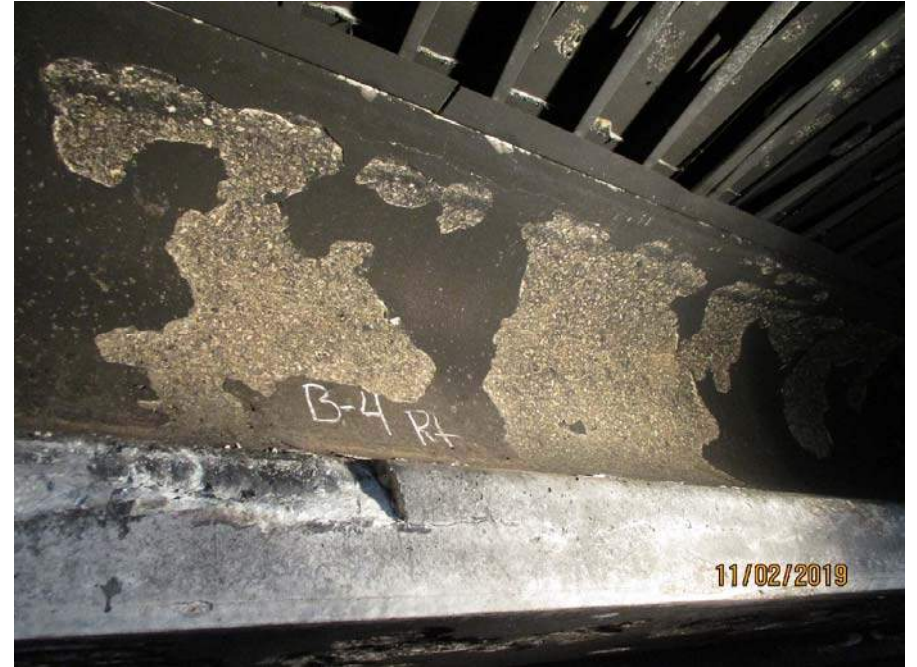
GIRDER "D" – WEB SPALLING, NORTH  
FACE

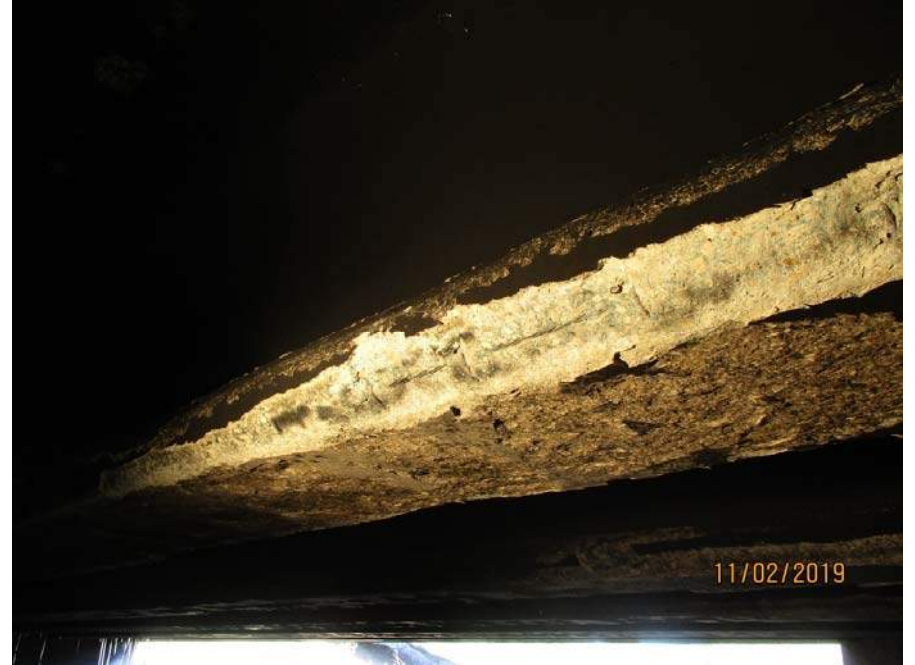
GIRDER "D" – BOTTOM FLANGE  
SPALLING AND EXPOSED STRAND,  
SOUTH FACE

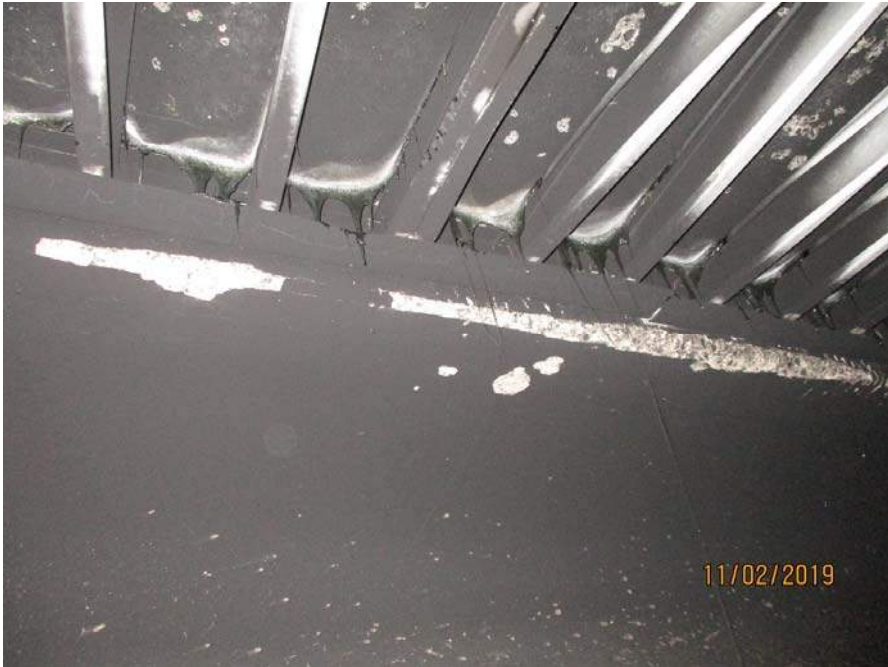
GIRDER "E" – TOP FLANGE SPALLS,  
NORTH FACE

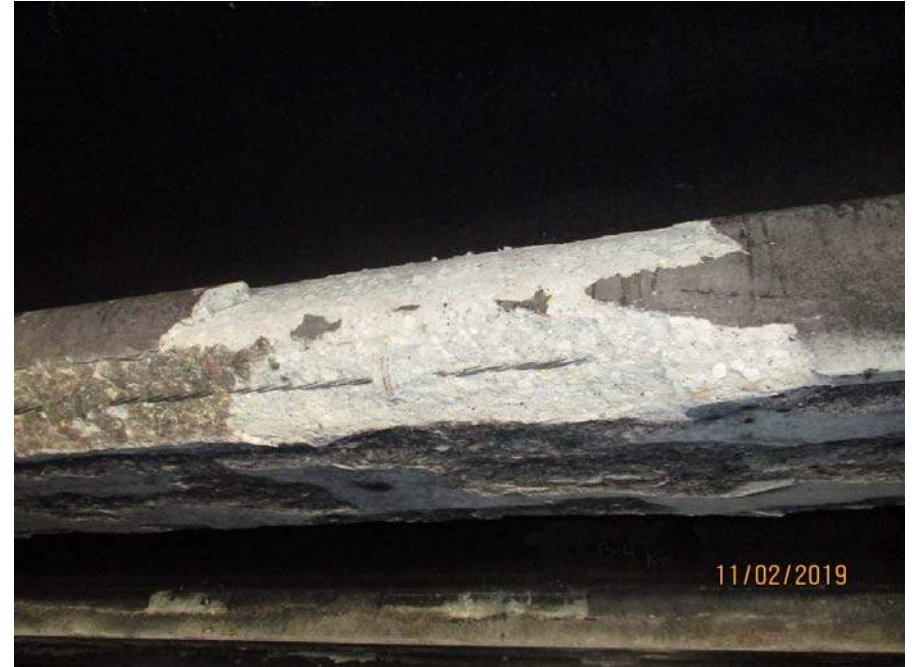
GIRDER "E" – BOTTOM FLANGE  
SPALLING AND EXPOSED STRAND,  
NORTH FACE

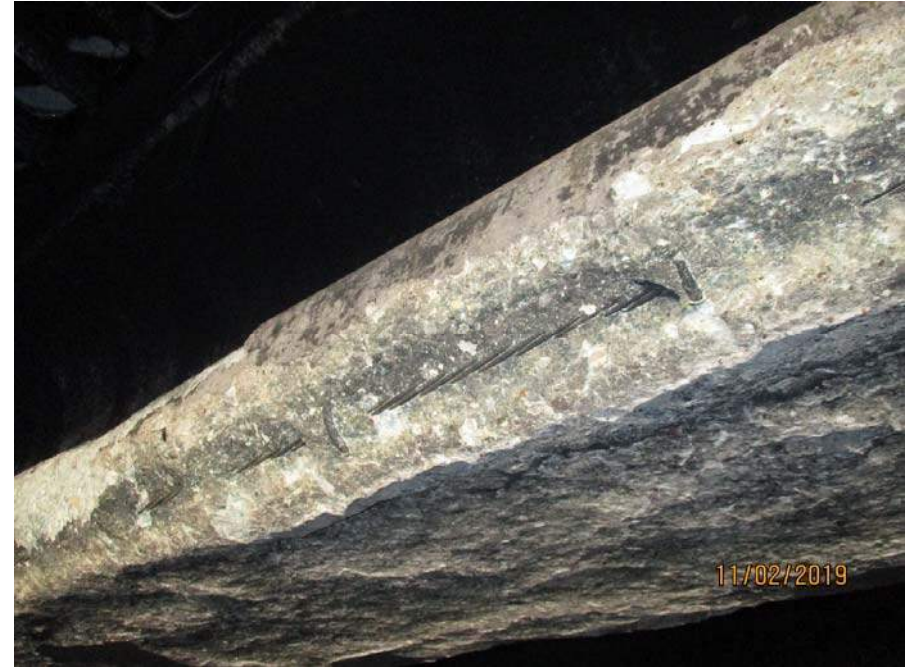
GIRDER "F" – BOTTOM FLANGE  
SPALLING AND EXPOSED STRAND,  
NORTH FACE

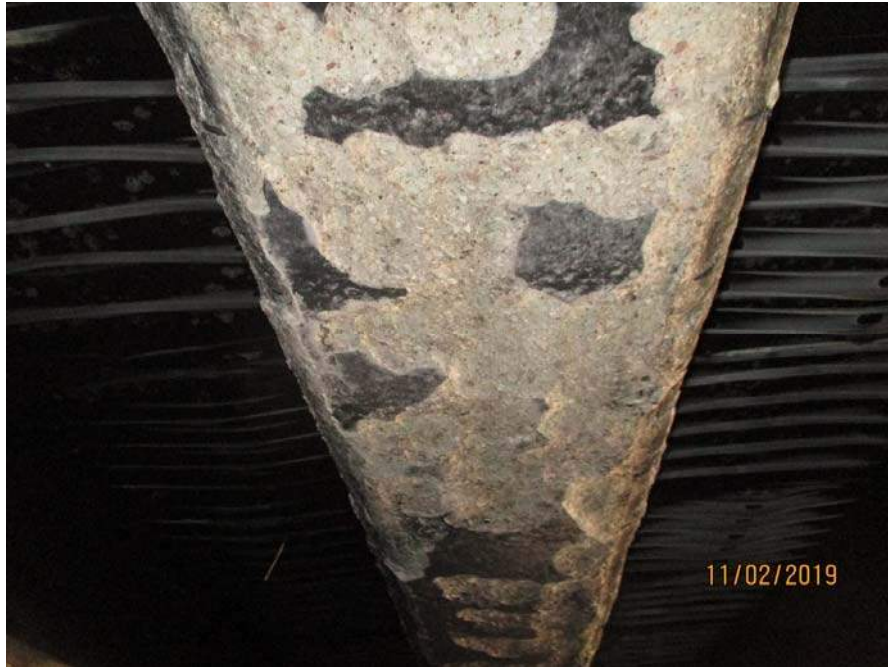
GIRDER "F" – BOTTOM OF BOTTOM  
FLANGE, EXTENSIVE SPALLING

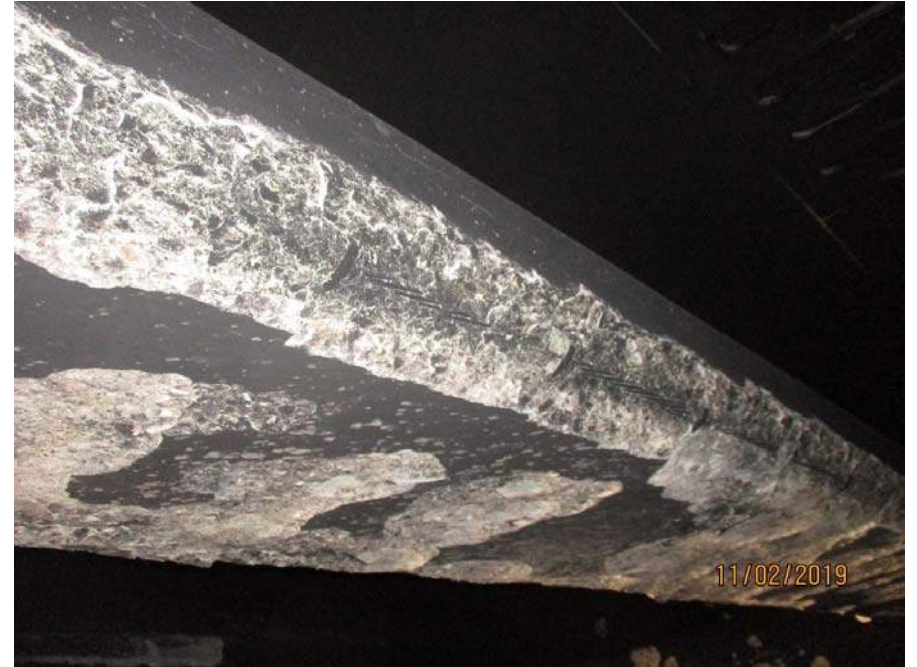
GIRDER "F" – BOTTOM FLANGE  
SPALLING AND EXPOSED STRAND,  
SOUTH FACE

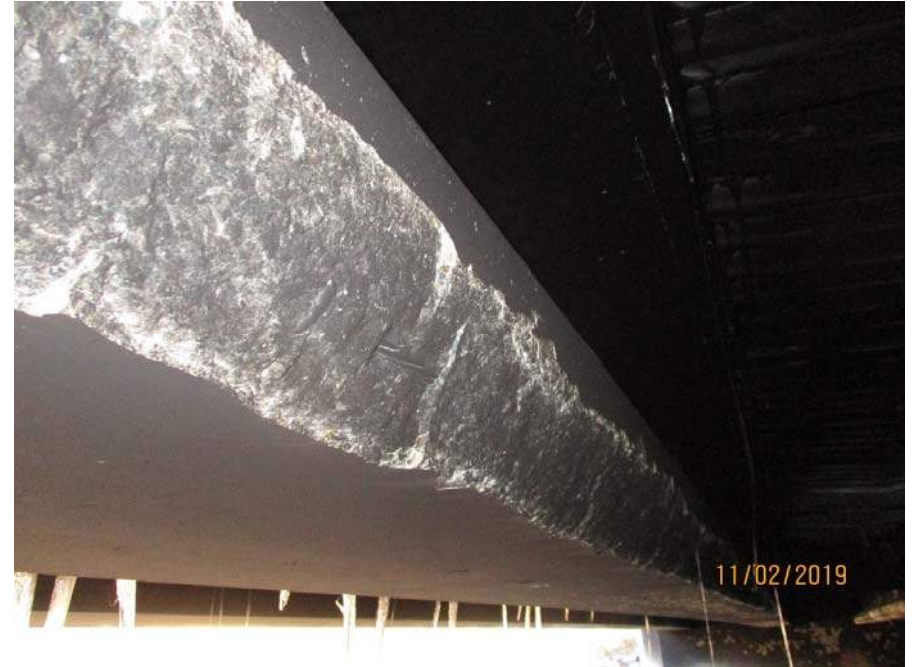
GIRDER "G" – BOTTOM FLANGE  
SPALLING AND EXPOSED STRAND,  
SOUTH FACE

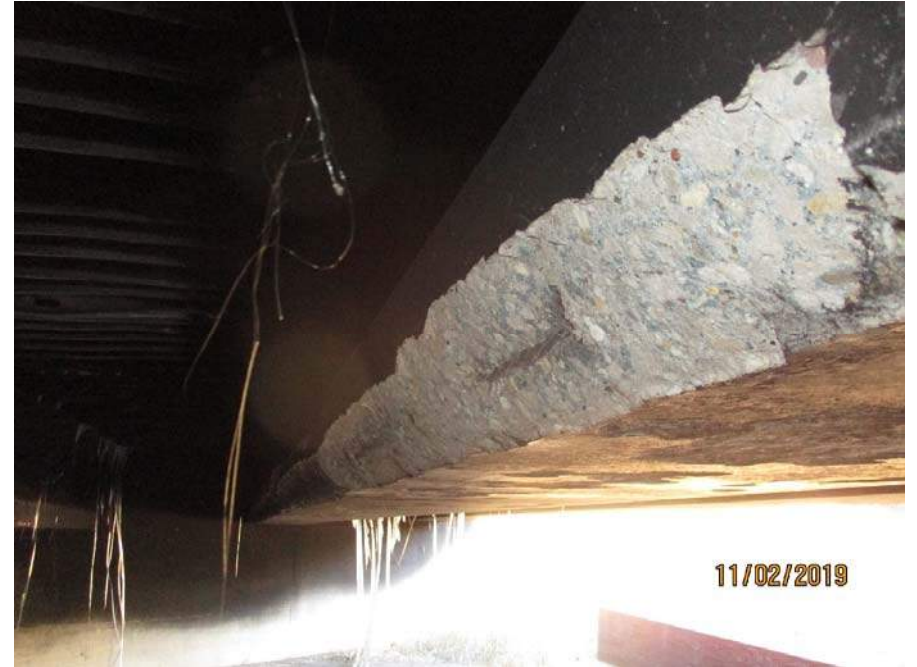
GIRDER "G" – BOTTOM FLANGE  
SPALLING AND EXPOSED STRAND,  
SOUTH FACE
